**Name of Dam: Little Creek Reservoir Dam**

**Inventory Number: VA 09506**

# **PHASE I INSPECTION REPORT**

**February 1981**

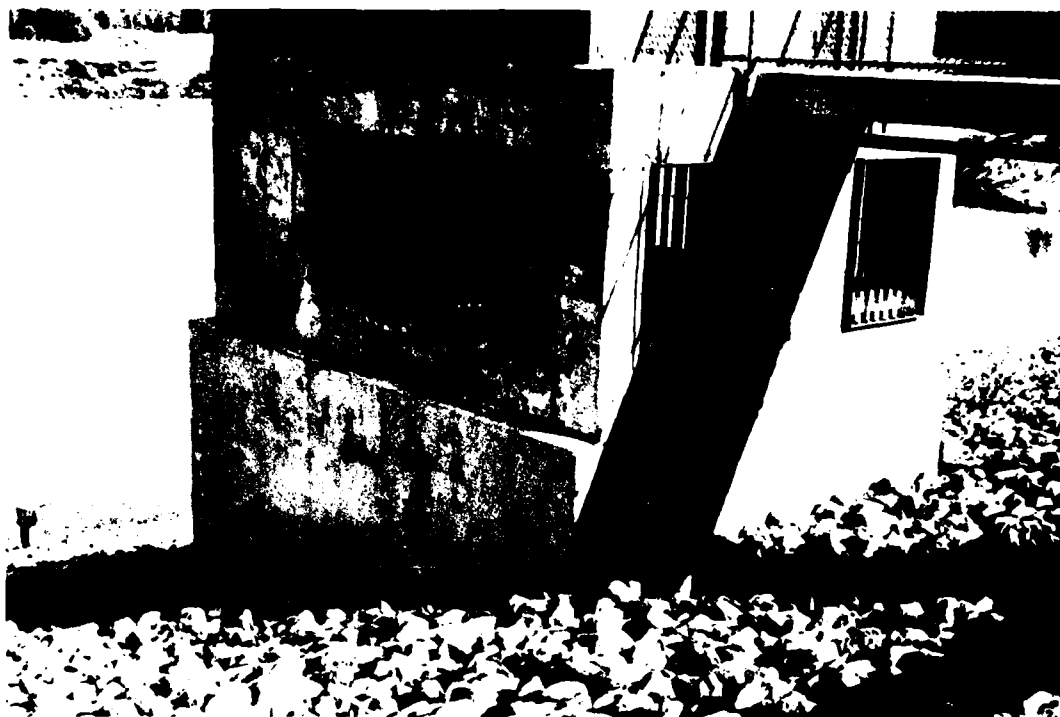
**PHOTO 1. Spillway Drop Inlet and 12-Inch Intake Pipe**

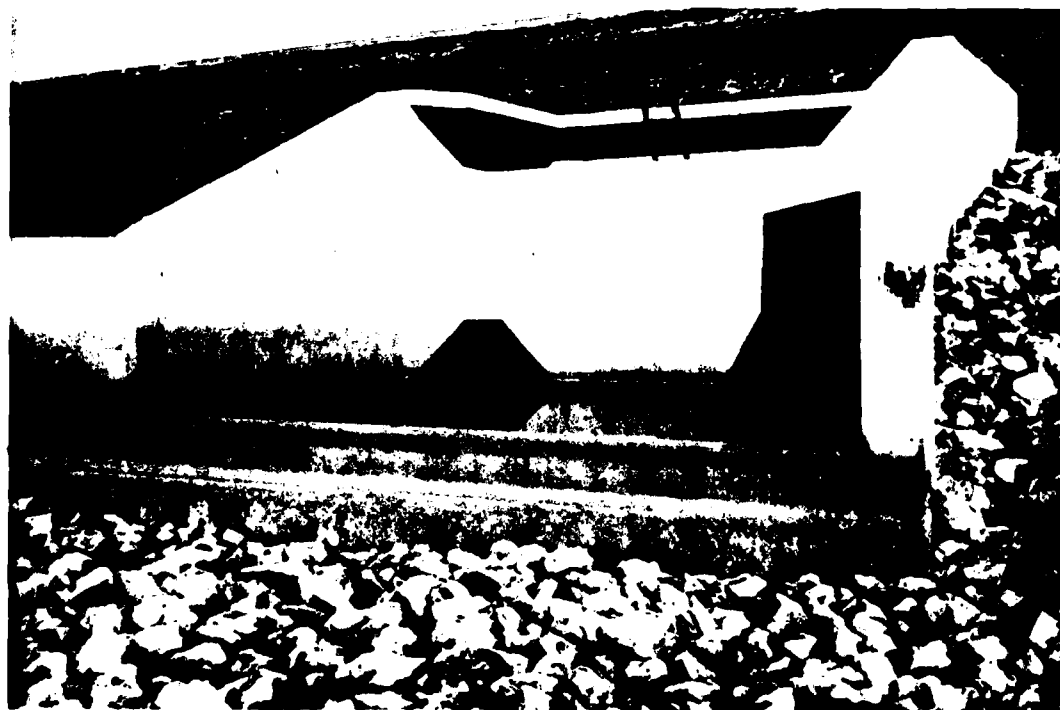
**PHOTO 2. Spillway Outlet Structure, Riprapped Toe of Dam**

VISUAL EXAMINATION OF	OBSERVATIONS	REMARKS OR RECOMMENDATIONS
CRACKING AND SPALLING OF CONCRETE SURFACES IN OUTLET CONDUIT	The outlet conduit, a 6 ft. diameter reinforced concrete pipe, is in good condition, with no cracking or spalling.	
INTAKE STRUCTURE	The intake structure is a rectangular reinforced concrete riser with interior dimensions 13 ft. by 18 ft. There are two 12 ft. long and two 4 ft. long inlets at elevation 60.0 ft. M.S.L. All four inlets are covered with adequate trash racks. The concrete on the intake structure is in good condition.	
OUTLET STRUCTURE	The outlet consists of a 6 ft. diameter reinforced concrete pipe. The pipe discharges into a concrete impact basin. Flow is directed against a concrete baffle with two roughly-triangular openings for energy dissipation and then over a 30 ft. wide end sill. The outlet area is well riprapped. The outlet structure is in good condition.

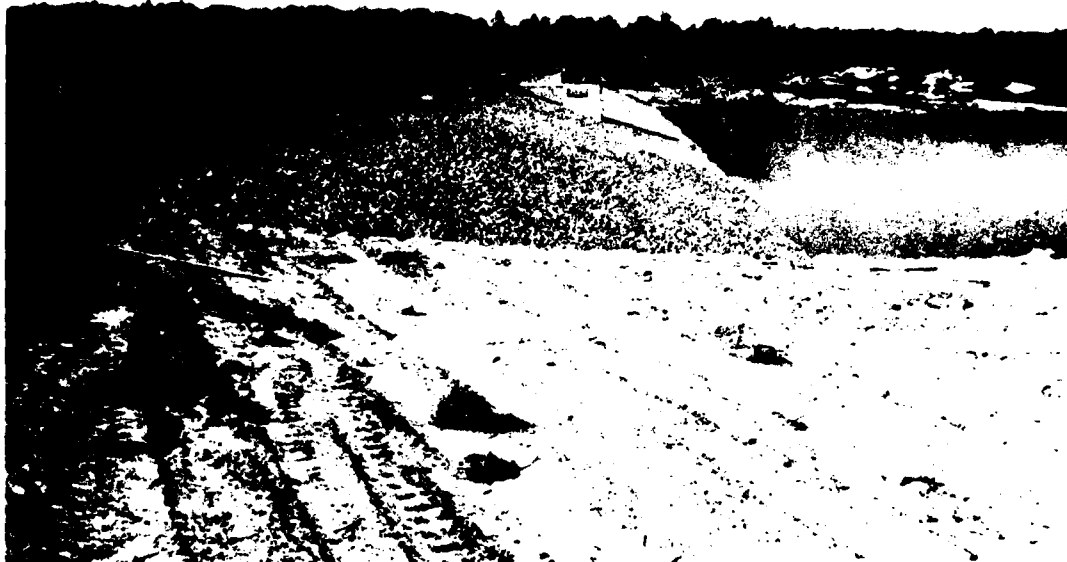
3.1.2 Dam: The embankment was found to be in generally good overall condition. The upstream embankment is entirely covered with riprap (Photo 3). The riprap consists of angular rocks approximately one foot in diameter. The junctions of the embankment and the abutments contain paved concrete chutes (Photo 6). The left upstream abutment is badly eroded below the chute (Photo 5). There is insufficient riprap at the outlet of the left downstream chute (Photo 6). The downstream embankment is slightly eroded and sparsely covered with grass. Local mulching and reseeding has been conducted recently. A very minor slump is located on the far right downstream embankment between the upper and middle benches. Jute matting has been used in the area of the concrete chutes on the downstream side of the dam to prevent erosion while vegetation is established. The entire downstream toe has been riprapped.

**PHOTO 3. Riprapped Upstream Embankment, Spillway Drop Inlet**

VISUAL EXAMINATION OF	OBSERVATIONS	REMARKS OR RECOMMENDATIONS
VERTICAL AND HORIZONTAL ALIGNMENT OF THE CREST	Horizontal and vertical alignment of the crest are both very good.	
RIPRAP FAILURES	The upstream embankment is completely covered with riprap. Riprap has also been placed along the entire downstream toe of the embankment to provide erosion protection during periods of high tailwater. The riprap consists of angular rocks approximately 1 ft. in diameter. All riprap was in good condition.
